NL INDUSTRIES/TARACORP SUPERFUND SITE GROUP
Leed Environmental, Inc.
Van Reed Office Plaza
2209 Quarry Drive, Suite C-35
Reading, PA 19609
Telephone: (610) 670-7310
Facsimile: (610) 670-7311

Re: NL Industries/Taracorp Superfund Site; Granite City, Illinois
Second 2016 Semi-Annual Operation and Maintenance Inspection (November 2016)

**NL Industries/Taracorp Superfund Site
Inspection Log - Operation and Maintenance**

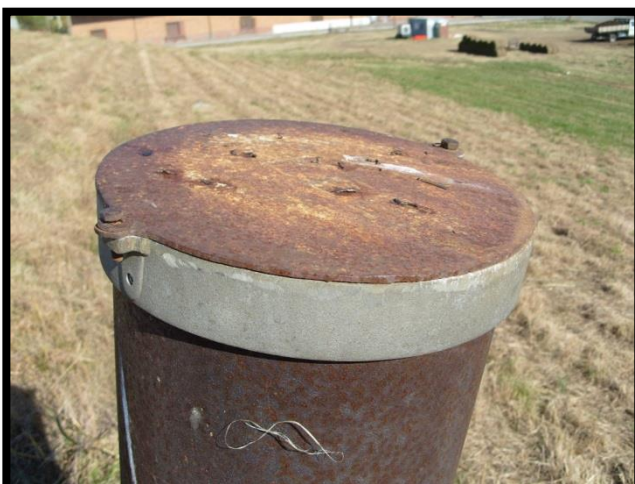
Site Structure	Inspected (yes/no)	Inspection Observations	Maintenance Work Performed or Required
Leachate Management System			
Riser pipe and locks	Yes	Riser pipe clean and in good condition. The lid on the riser pipe was locked.	
Leachate levels in sump	No	EWI removed leachate from the sump in June 2014 as part of the five-year review groundwater monitoring event.	
Necessary sampling activities	No		
Necessary leachate disposal	No		
Comments			
Concrete Drainage Channel			
Evidence of cracks or obstructions	Yes	No significant cracks or obstructions.	
Areas of erosion	Yes	No erosion observed.	
Comments			
Asphalt Covers - Integrity			
Evidence of broken asphalt or fissures	Yes	Some minor asphalt cracking and deterioration was observed in small areas along the sides of several paved alleys in Venice. Evidence of recent paving / patching of the alleys by Venice Township was observed along 6th Street (Attachment 4, photograph 9).

Photograph 44: Locked lid on leachate riser pipe (locked lid installed fall 2007).

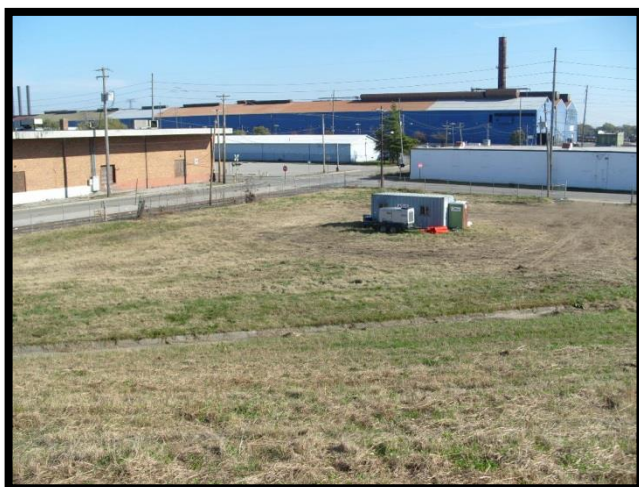
Photograph 45: Area of former BV&G Truck Service buildings (view east from northeastern side of Taracorp pile cap).

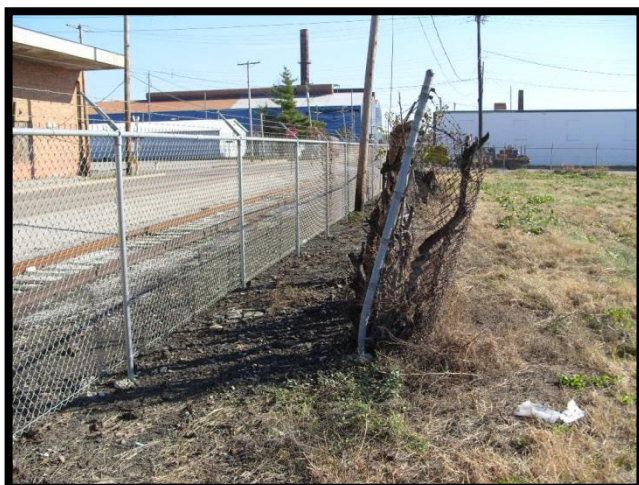
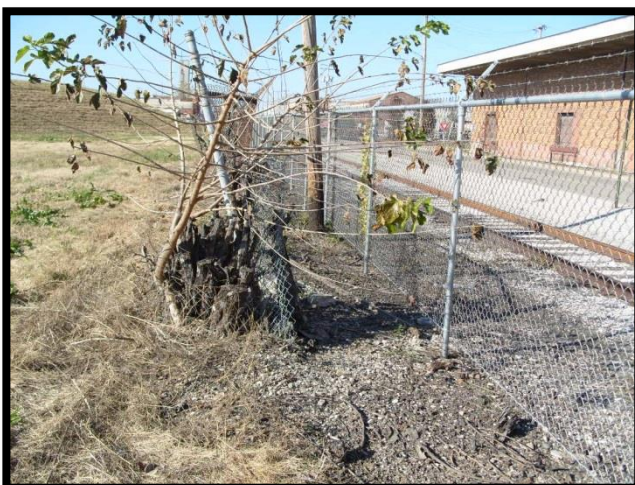
Photograph 47: Older and newer fence near former BV&G Truck Service buildings along railroad tracks (view northeast).

Photograph 48: Older and newer fence near former BV&G Truck Service buildings along railroad tracks (view northwest).

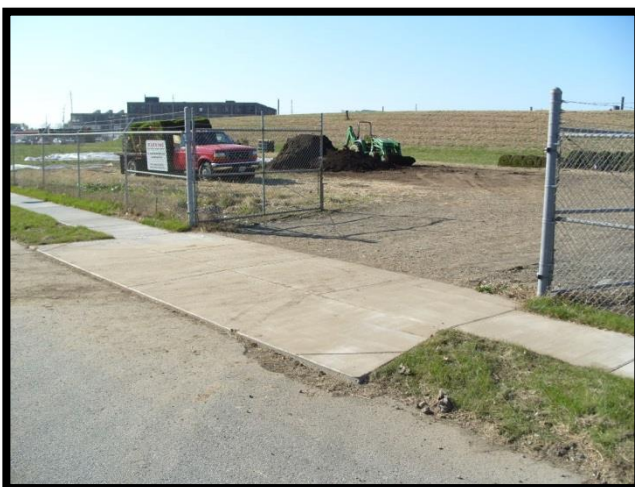
Site Structure	Inspected (yes/no)	Inspection Observations	Maintenance Work Performed or Required
Security Fence:			
Gates/locks secure and operative	Yes	Gate near 16th and State Streets was locked at the time of the inspection. The gate and lock were secure and operative.	
Evidence of rust, cuts, deterioration	Yes	No significant rust, cuts, or deterioration.	Mr. Justin Shrum, the owner/operator of All Pallet Service on the neighboring property, repaired the damaged fence that was observed during the June 2016 semi-annual operation and maintenance inspection.
Evidence of unauthorized entry	Yes	No evidence of unauthorized entry.	
Burrowing or tunneling under fence	Yes	No evidence of burrowing or tunneling under fence.	
Damaged barbed wire	Yes	No evidence of damaged barbed wire.	
Comments			
Warning Signs:			
Warning signs (on fence around 1555 State Street property and Taracorp pile property)	Yes	In October 2014, the Group's contractor, TNT Fence Company, installed five warning signs on the perimeter security fence: (1) one sign along State Street adjacent to the locked gate near State Street and 16th Street; (2) two other signs along State Street; (3) one sign along the railroad tracks near the intersection of 16th Street and Edison Avenue; and (4) one sign near the Metalico/Mayco property. No problems with the signs were identified during the November 2016 inspection.

Photograph 50: Concrete entranceway gate near 16th and State Streets.

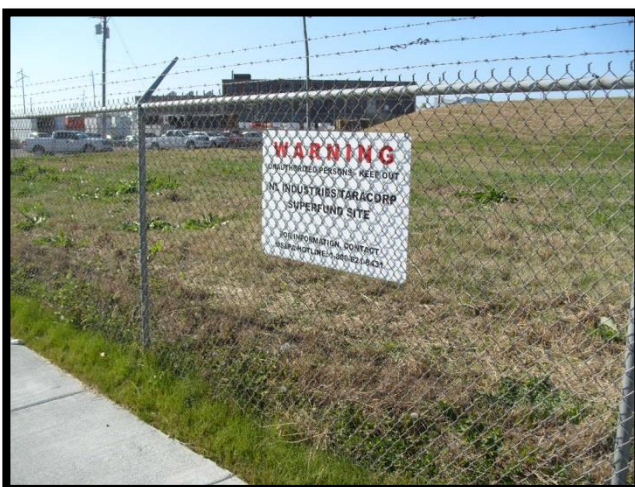
Photograph 54: Warning sign along State Street.

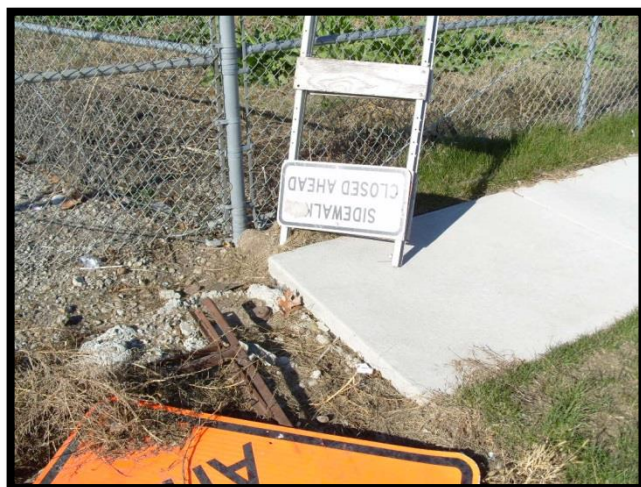
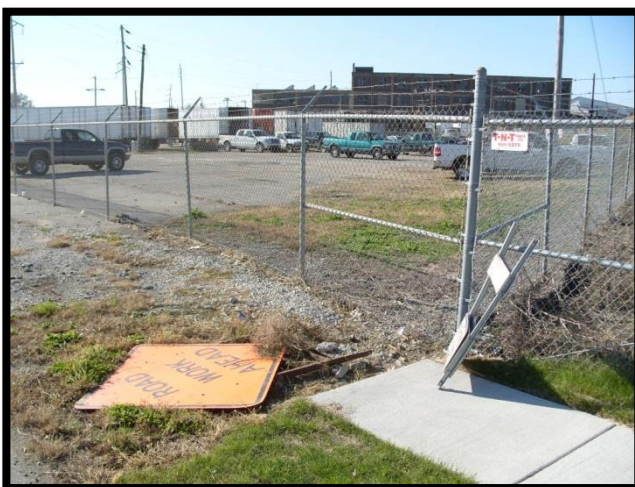
Photographs 55 and 56: Southern end of concrete sidewalk on 1555 State Street property (adjacent to former Rich Oil property).

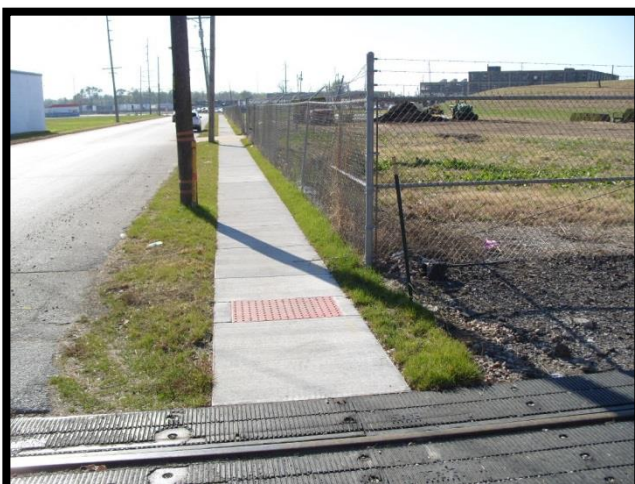
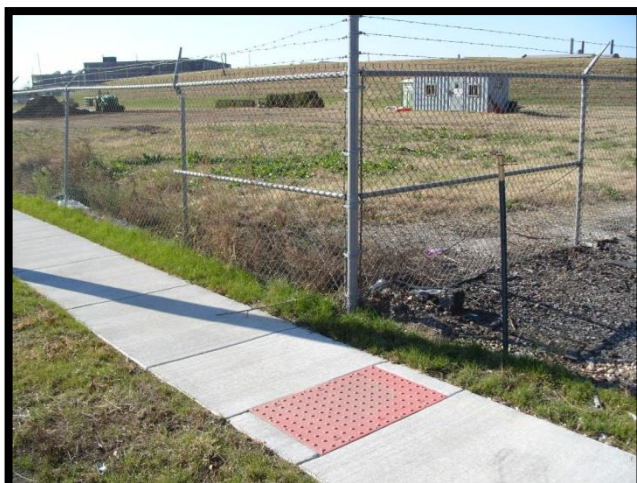
Photograph 62: End of sidewalk along railroad tracks.

Photograph 63: End of sidewalk along railroad tracks.

Photograph 64: End of sidewalk along railroad tracks.

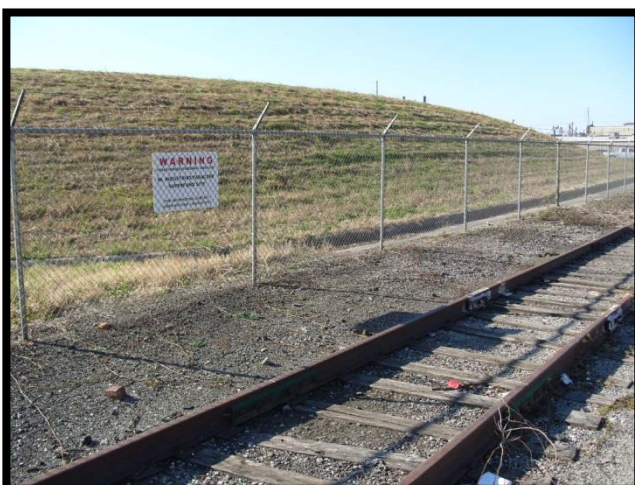
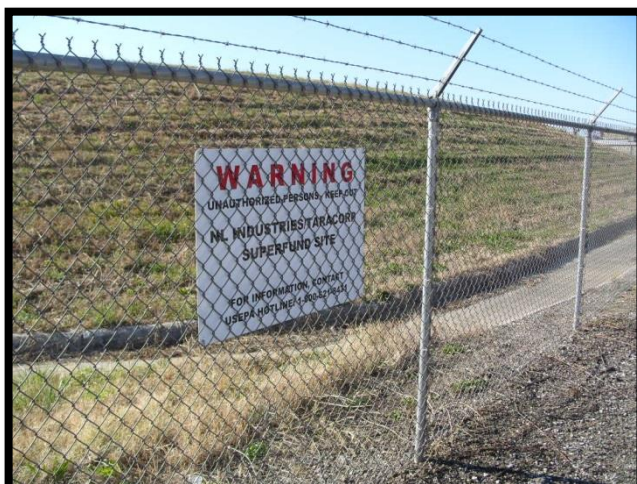
Photograph 66: Warning sign on fence along railroad tracks near 16th Street and Edison Avenue.

Photograph 67: Warning sign on fence along railroad tracks near 16th Street and Edison Avenue.

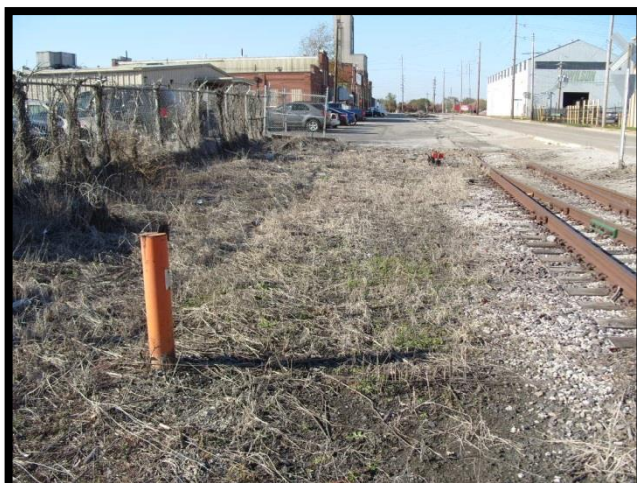
Photograph 69: Monitoring well, fence, and vegetation along railroad tracks and 16th Street.

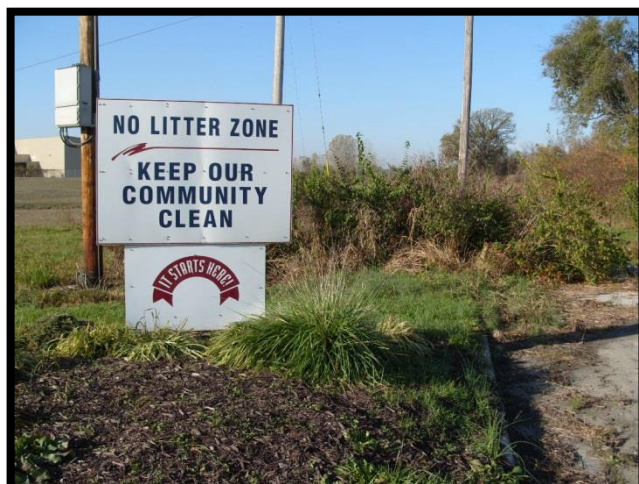
Photograph 1: Schaeffer Road property.

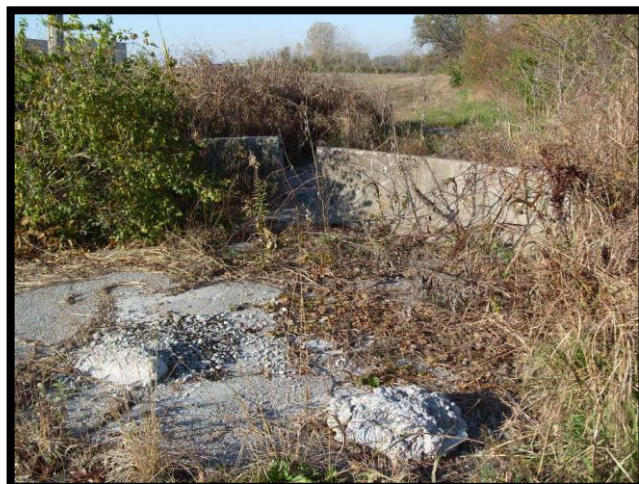
Photograph 3: Schaeffer Road property.

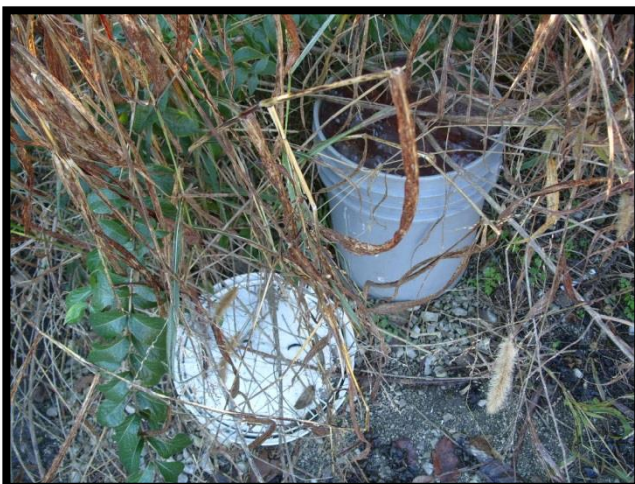
Photograph 4: Schaeffer Road property, 5-gallon container.

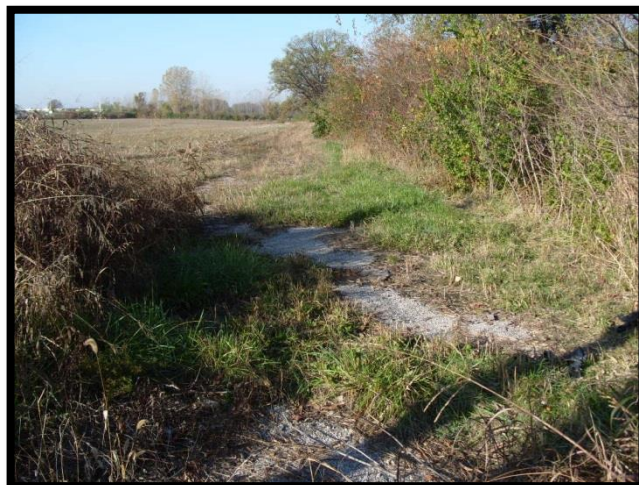
Photograph 5: Schaeffer Road property.

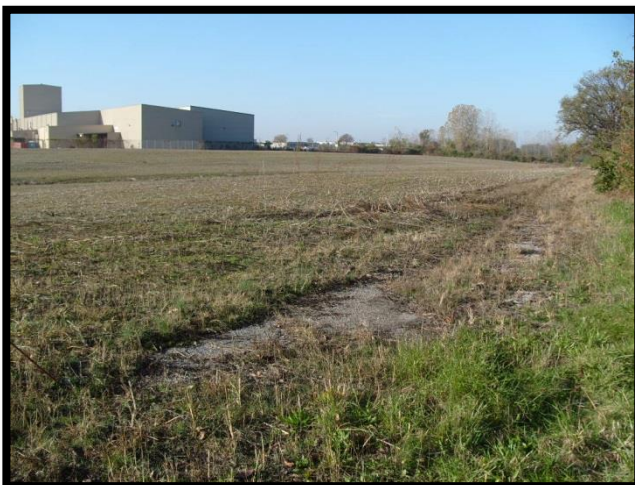
Photograph 6: Schaeffer Road property.

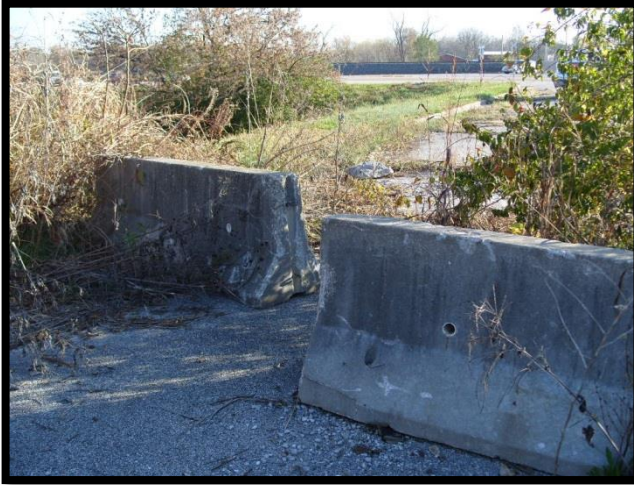
Photograph 7: Schaeffer Road property.

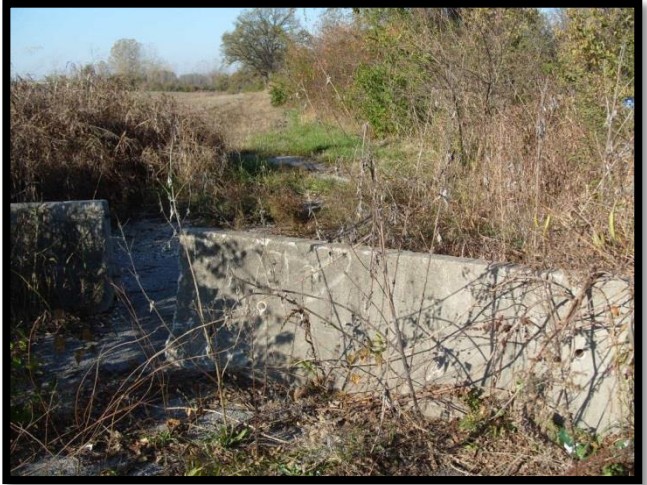
Photograph 8: Schaeffer Road property.

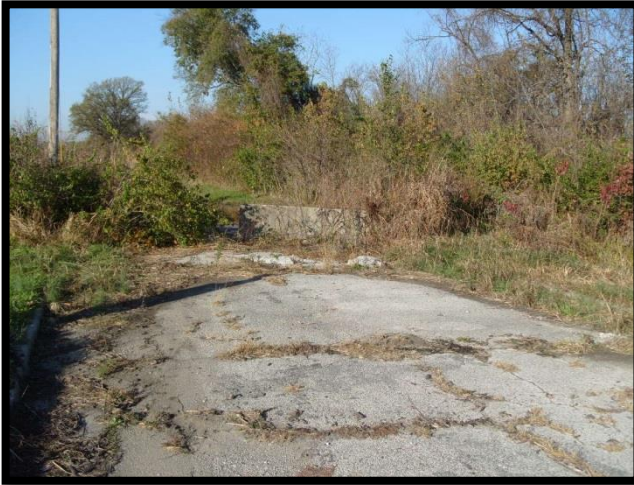
Photograph 9: Schaeffer Road property.

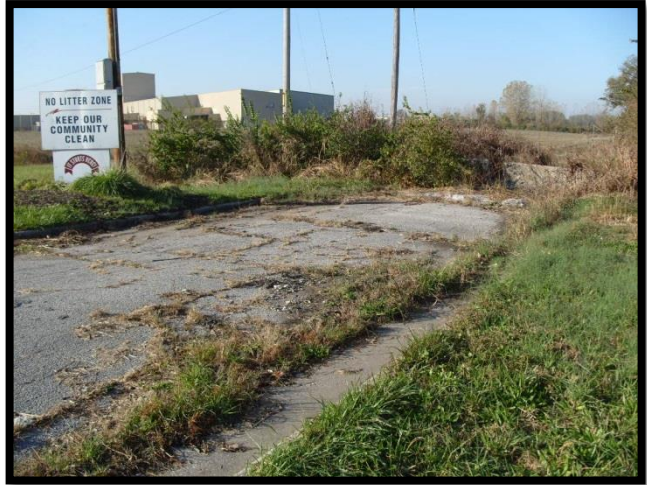
Photograph 10: Schaeffer Road property.

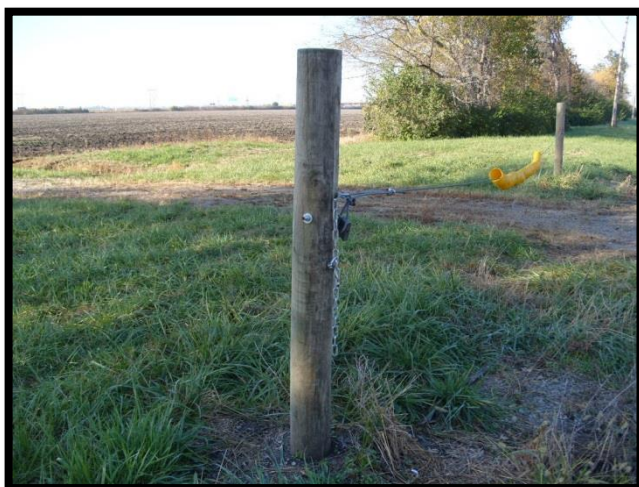
Photograph 1: Sand Road property, gate.

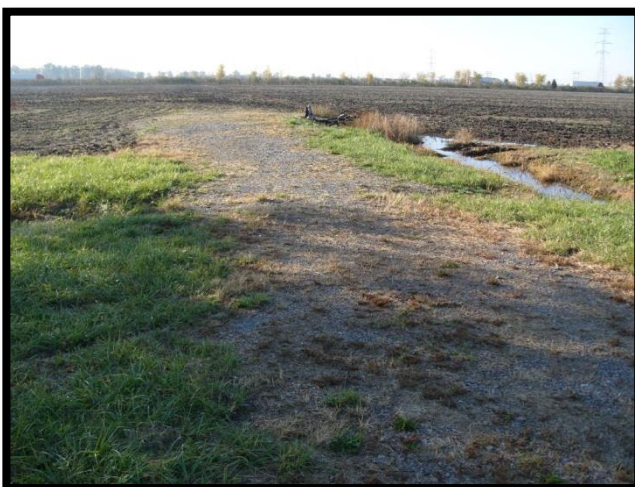
Photograph 2: Sand Road property, entrance road.

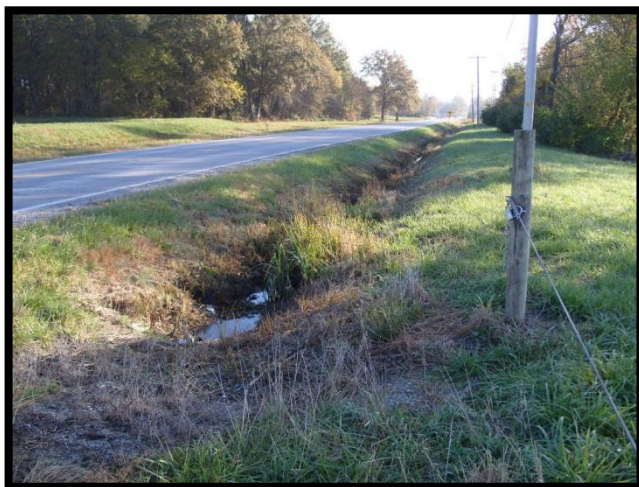
Photograph 3: Sand Road property.

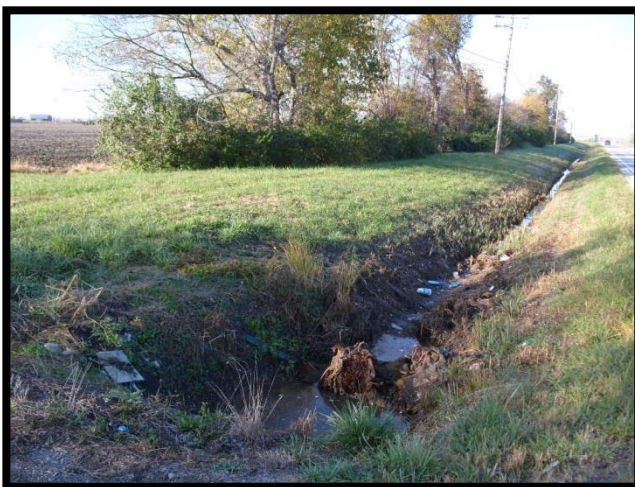
Photograph 4: Sand Road property.

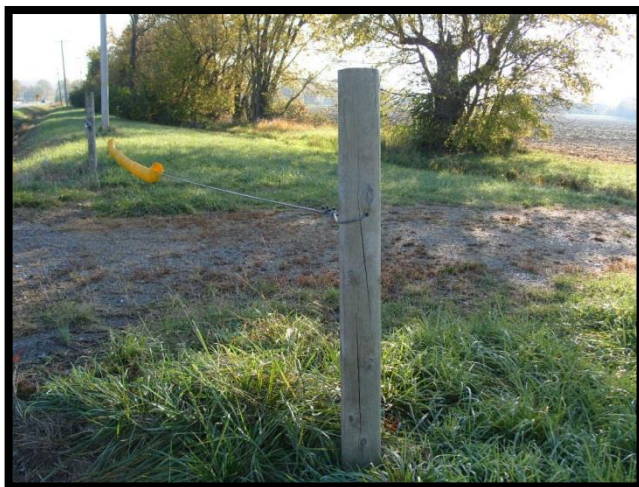
Photograph 5: Sand Road property, gate.

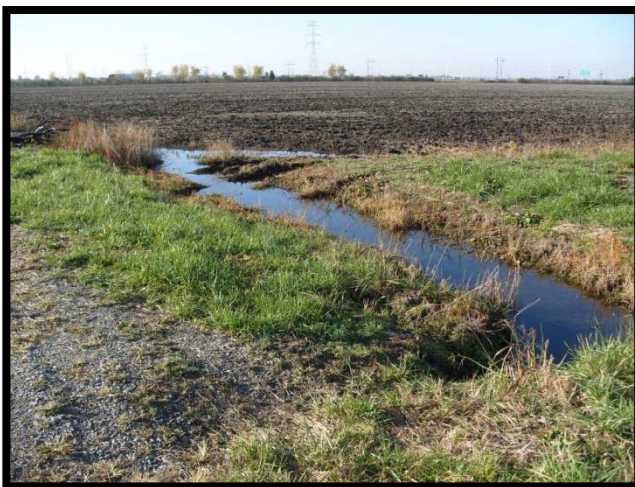
Photograph 6: Sand Road property.

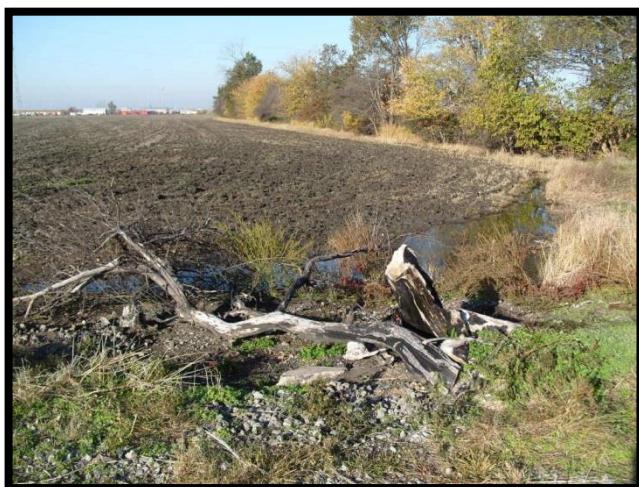
Photograph 7: Sand Road property.

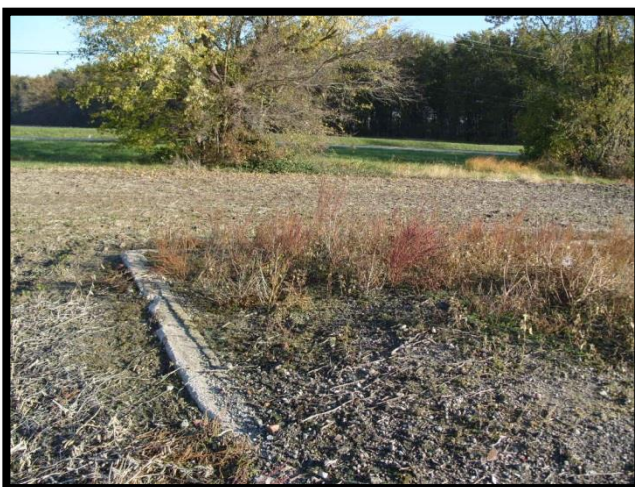
Photograph 8: Sand Road property, concrete foundation.

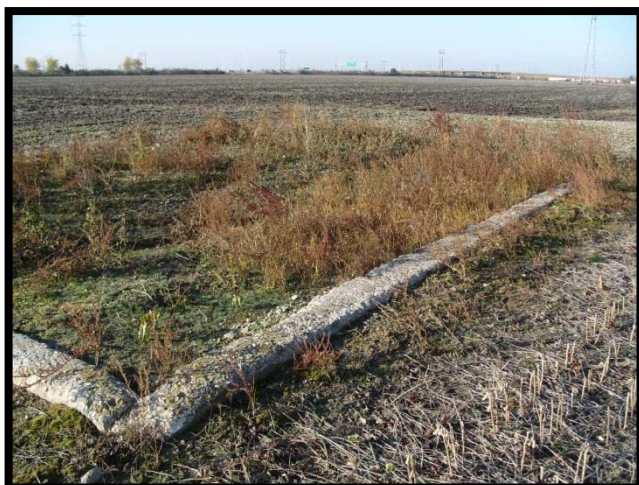
Photograph 9: Sand Road property, concrete foundation.

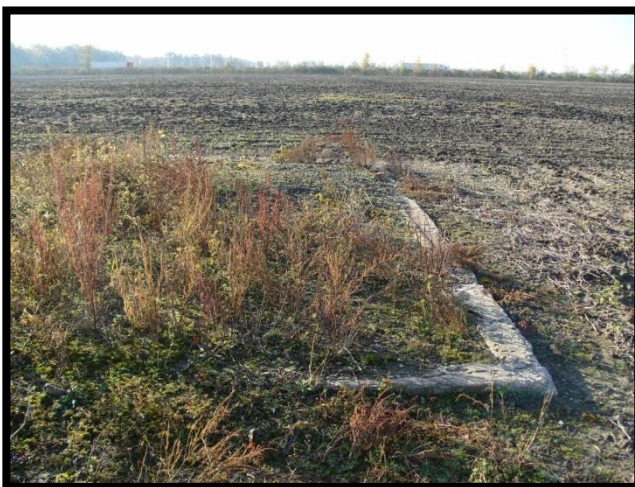
Photograph 12: Sand Road property, former concrete foundation.
